Hurricane Kate

November 15-23, 1985

Department of Natural Resources
Division of Beaches and Shores
Post Storm Report No. 86-1
September, 1986
By Ralph Clark

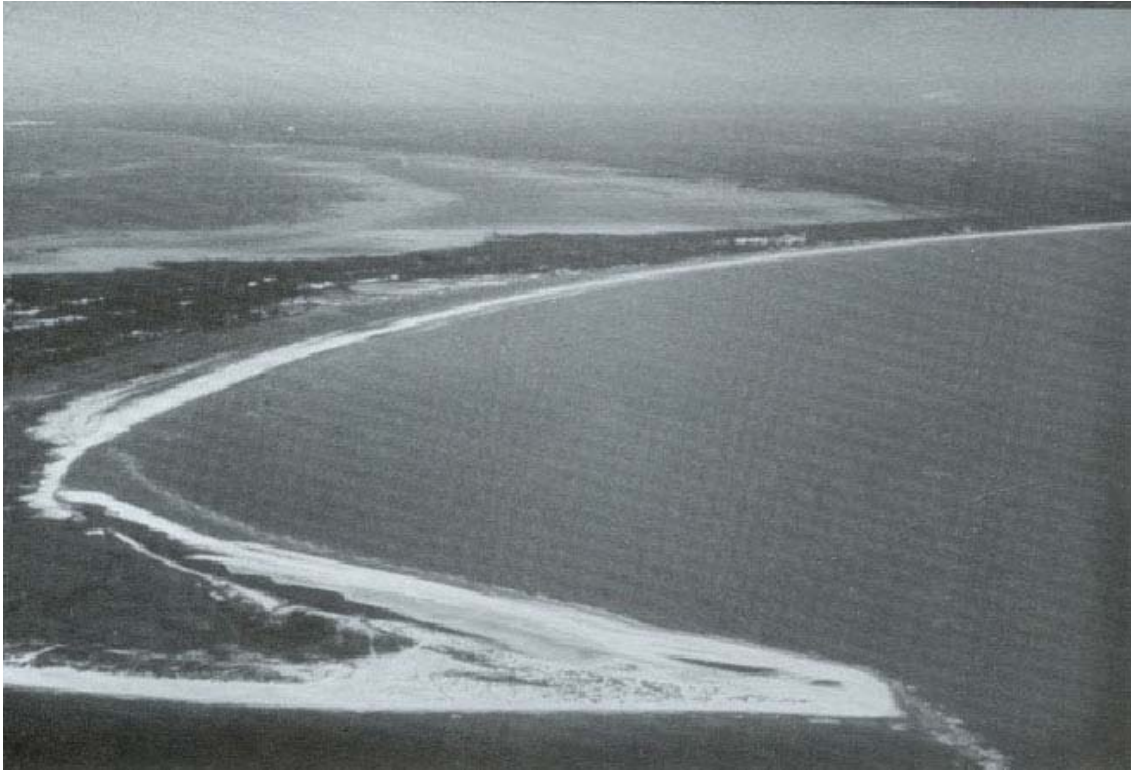
Cape disappeared after Elena passed by approximately 30 miles offshore on the evening of September 1. Another approximately 1,000 feet of the Cape was removed by hurricane Kate on November 21. Figure 18 shows Cape San Blas from the air in November, 1984 and Figure 19 taken on November 24, 1985, shows the remains of the Cape, three days after Kate 's impact and after nearly one half mile of the Cape was lost to the two hurricanes. The exposed southwest shore of Cape San Blas sustained heavy beach and dune erosion. About 200 feet of the end of the beach access road was destroyed (Figure 20). Profile data obtained by the Bureau of Coastal Data Acquisition adjacent to this beach access road revealed the barrier dune which had had a peak elevation of about +13.5 feet NGVD had been completely destroyed. An elevation of +3 feet NGVD remained at the site of this barrier dune after Kate. The entire barrier dune along the southern one mile of Gulf front beach south of the beach access road to the south tip of the Cape was totally destroyed. Most of the Cape is federally owned and extensive roofing damage was sustained by the several government buildings. In addition numerous equipment structures were damaged and a tall radio antennae was destroyed.

FIGURE 18. Cape San Blas, November, 1984 (Photograph provided by Kevin R. Bodge, University of Florida)

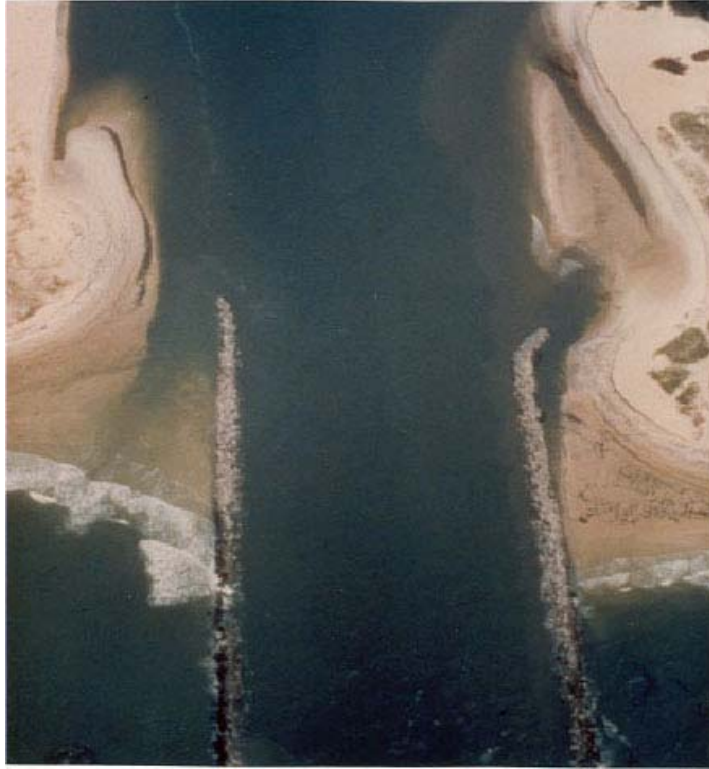
As reported in Post-Storm Report 85-3, the inlet's rock jetties at Sike's Cut were breached by the substantial shoreline recession caused by Elena on September 1. Figure 39 is an aerial photograph of the inlet prior to Kate. The Mobile District Corps of Engineers conducted an emergency dredging operation in the channel after Elena, removing shoals and placing the material in the breach between the east jetty and the shoreline. Although some erosion did occur in this filled area immediately east of

FIGURE 39. Sike's cut (St. George Island Channel) in November, 1985 prior to Kate (photograph by Kevin R. Bodge).
